Costa Rica Roofing Defects & Solution

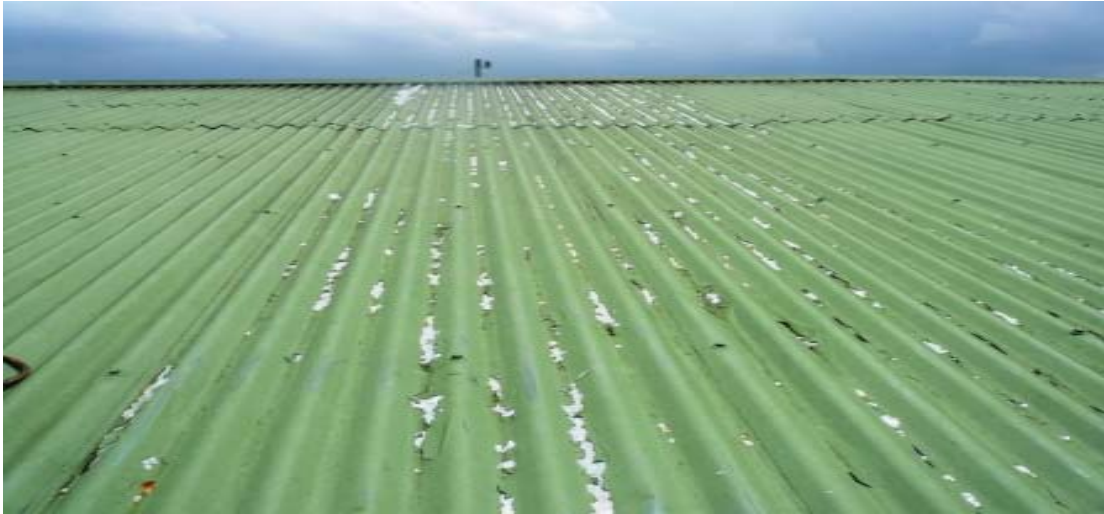
One method that the local Latinos use to maintain their roofs is to periodically paint the metal laminates with anti-corrosive paint. Anyone who has purchased paint in Costa Rica knows, the paint is expensive and usually doesn't last more than a year on a roof down here under the intense ultraviolet rays of the sun, less than 10 degrees from the equator. When the paint peels off the metal laminates, it's a lot of work to clean the loose paint and prepare the surface for another coat of new paint. If the roof surface is not maintained consistently with sufficient anti-corrosive paint, corrosion begins on the exterior surfaces of the laminates as well as on the undersides of the laminates and spreads as the metal is exposed to further moisture.

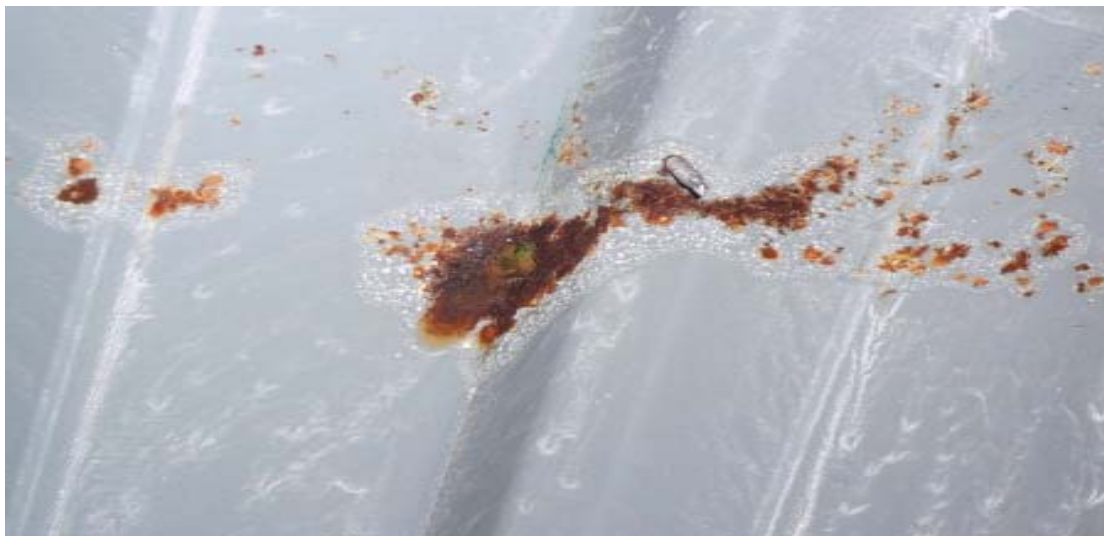
In Costa Rica, the majority of roofing systems are corrugated metal laminates, screwed into light weight wood or metal structures. Because proper sheathing and waterproofing underlayment are seldom used, there is nothing preventing moisture from infiltrating into the overhanging soffits and inside the dwellings. Additionally, the part of metal laminates that overhang the gutters is exposed to a great deal of moisture and when corrosion begins on the bottom of metal laminates, it spreads like cancer.

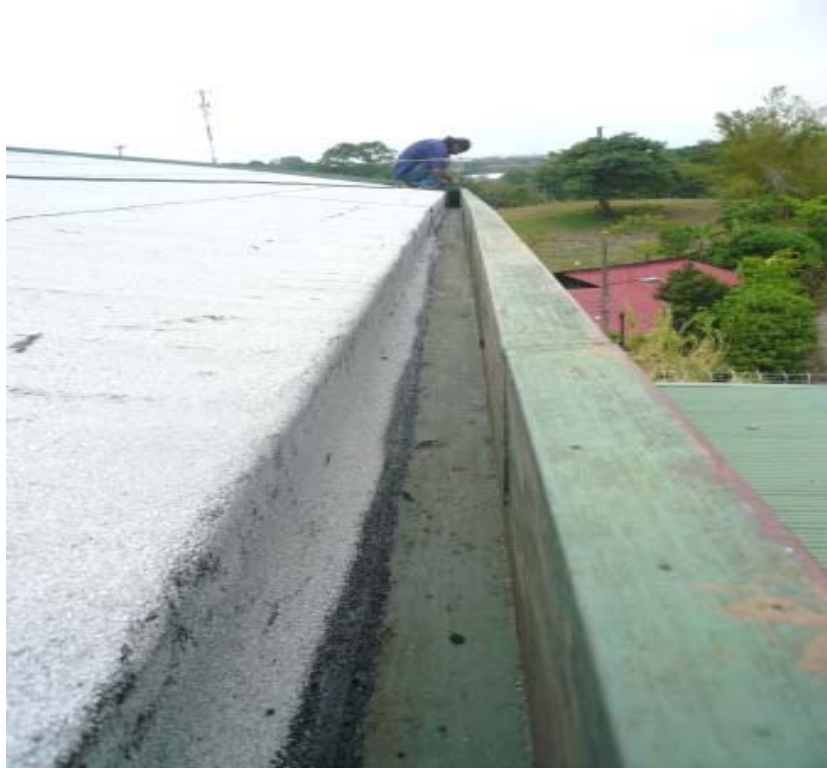
In a few instances, I've inspected roofing installations where plywood underlayment was utilized. However, drip edge flashing is rarely used and when the gutters fill up during heavy rains, the water backs up onto the underlayment and causes the plywood to warp as well as entering inside the soffits and onto the fascias. The absence of flashing is one of the most common problems here in Costa Rica and most local tradesmen don't know how to properly install flashing materials.

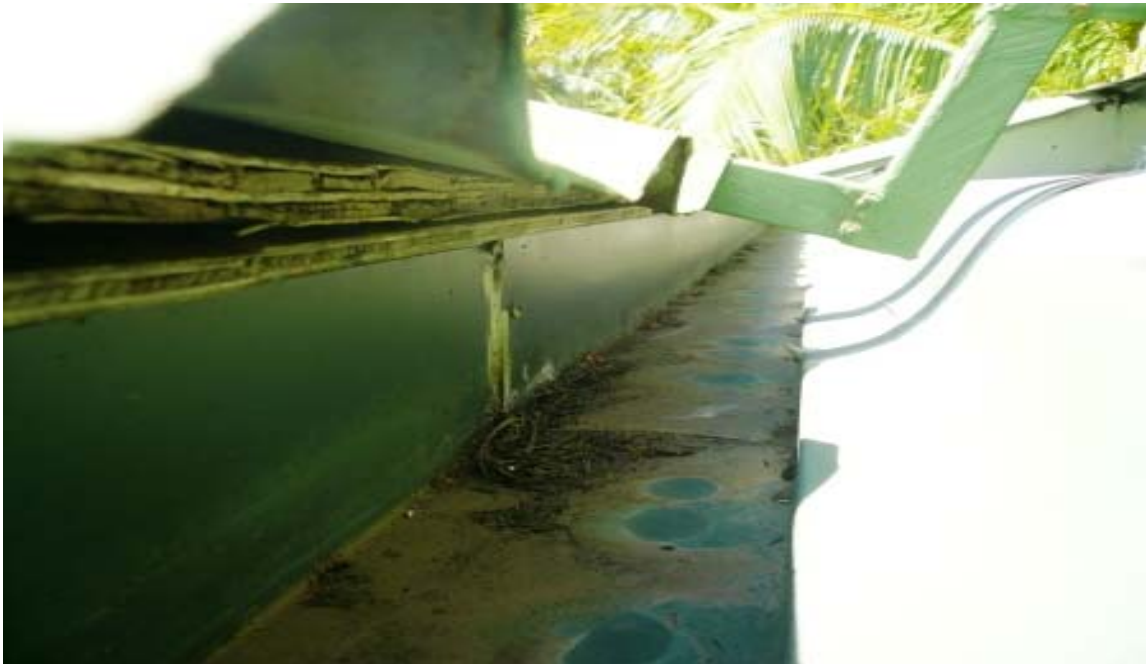
The shortcomings of these types of inferior roofing installations result in a variety of damages to dwellings. When rainwater builds up inside the gutters, it flows out from the back side where the gutters are attached to the roof structure. Once the water is inside the overhangs, it causes moisture damage to the ceilings of the soffits and eventually becomes visible on the exterior of the soffit ceiling materials.

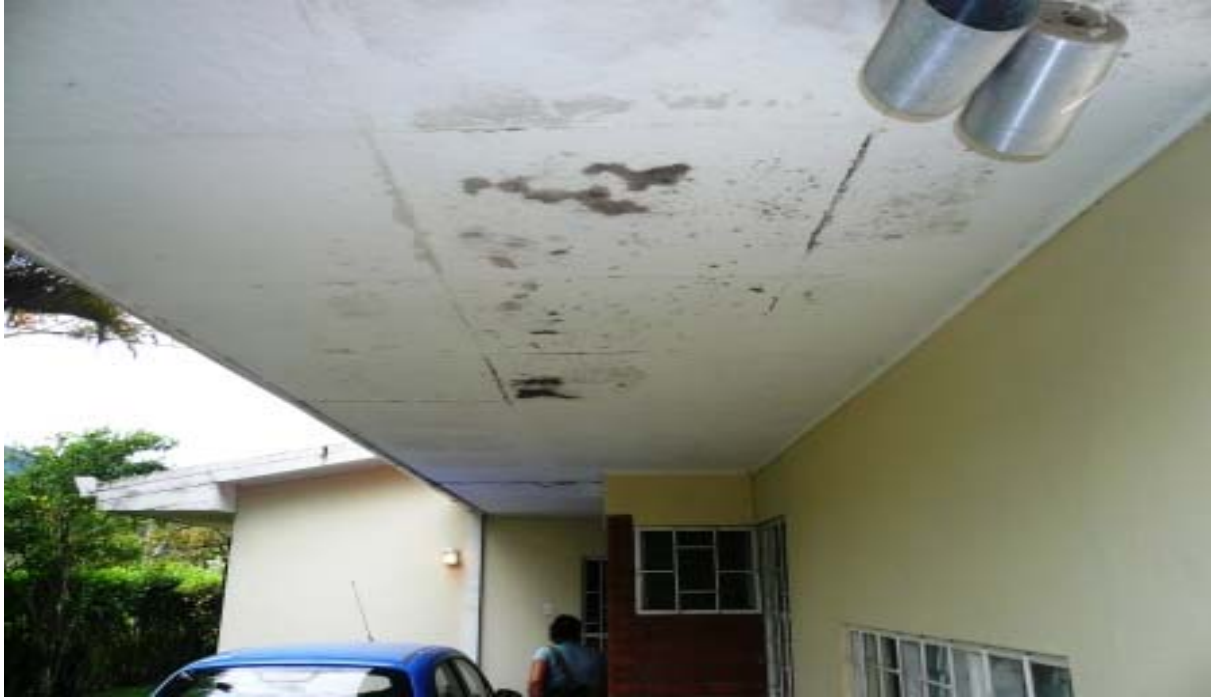
Additionally, this same water accumulating inside the gutters flows onto the fascia materials and eventually stains the surface. These soffits and fascias in these two photos have cementitious laminates for the finished surface, commonly referred to as "Fibrolit" here in Cost Rica. These laminates were not designed to be taped and plastered like drywall and therefore cracks are always visible where they join together.

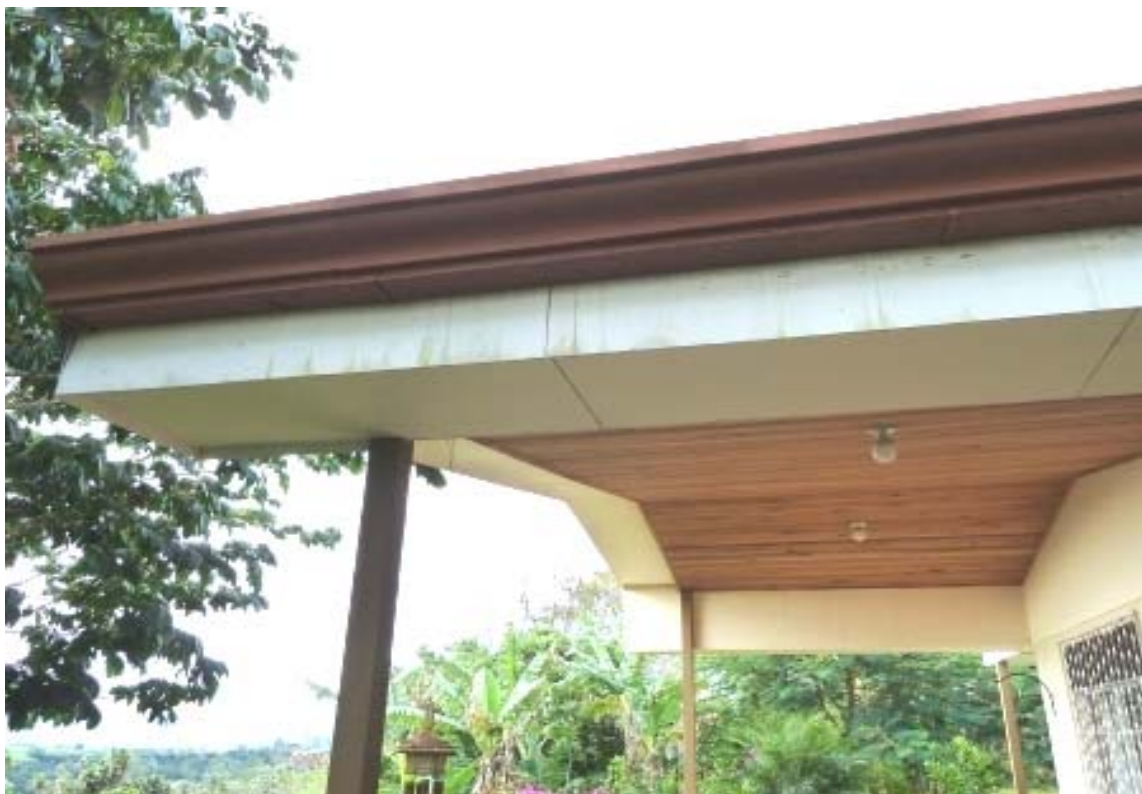
During the past few years, materials such as green drywall and DensGlass laminates have been used to cover the soffits and fascias and when these products become moist from water infiltration, the tape and plaster along with the synthetic materials utilized to fabricate the laminates becomes damaged. These modern materials are much more complicated and expensive to repair than the typical cementitious laminates. The old cementitious laminates don't deteriorate rapidly like the modern materials and the local custom here is to paint the cementitious laminates every year to hide the water stains and mold. So if you're looking at homes during the dry season, the soffits and fascias may appear clean because they've recently received a fresh coat of paint. Only an experienced construction inspector with a keen eye can spot the tell tale signs of water infiltration once it's been covered with fresh paint.

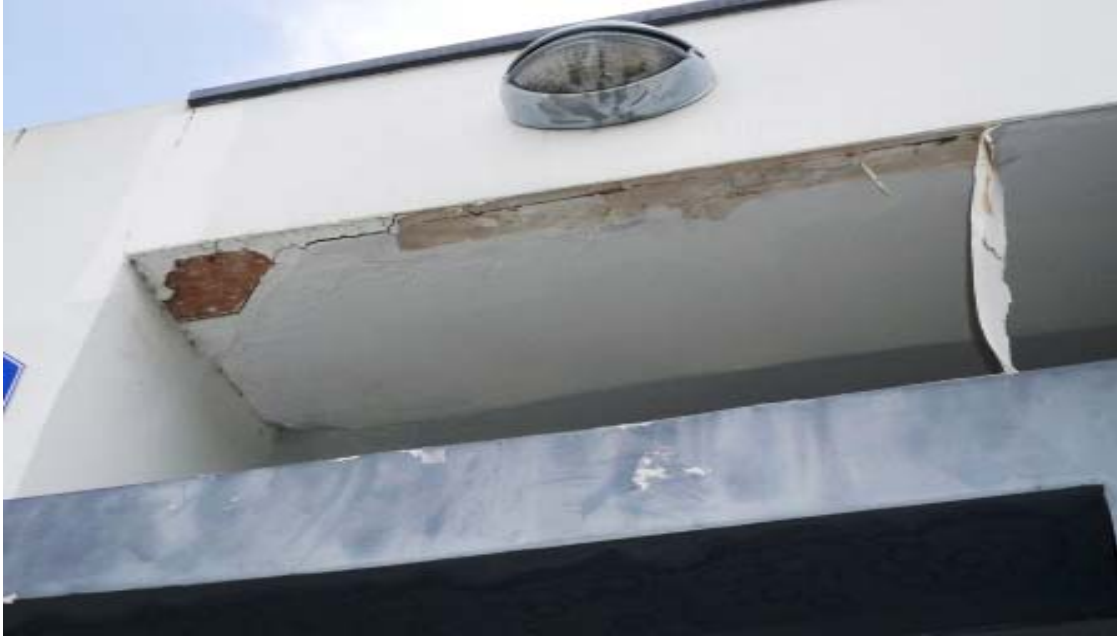
All of the above problems were caused by the gutters filling up with rainwater and overflowing inside the soffits and onto the fascias. The most common cause of gutters filling up with rainwater is the lack of maintenance. If the gutters are full of debris, the holes for the downspouts become blocked and the water can't escape.

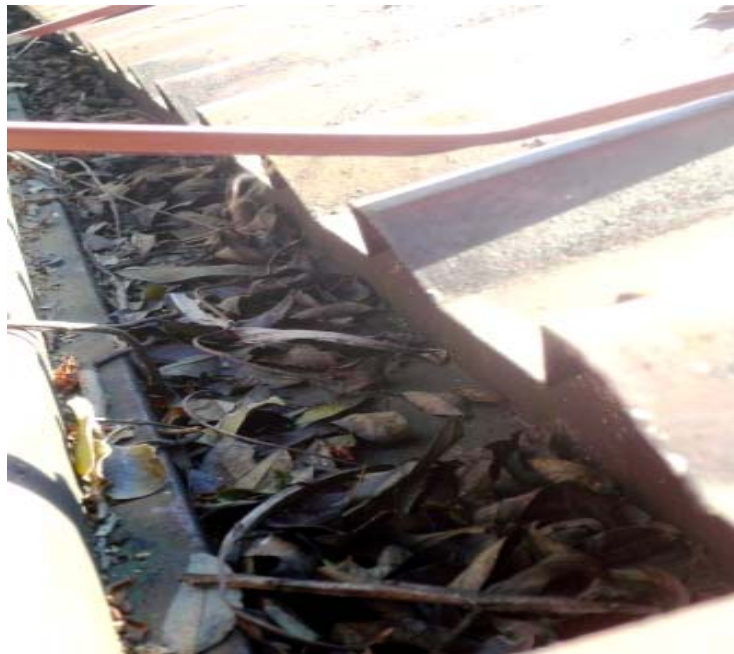
In the past, most gutters did not have downspout tubes and the custom was to install small cone type drains, commonly referred to as "conos" in Costa Rica. Then the locals install chains inside the conos to divert the flow of rainwater. However, these chains obstruct the flow of water and cause the rainwater to accumulate inside the gutter.

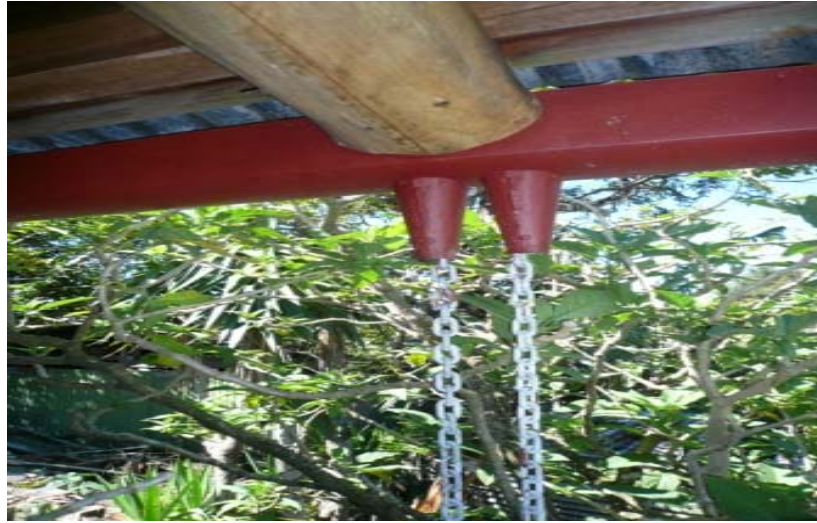
Furthermore, many gutters were fabricated with small drains and very little water can flow out through a tiny little hole.

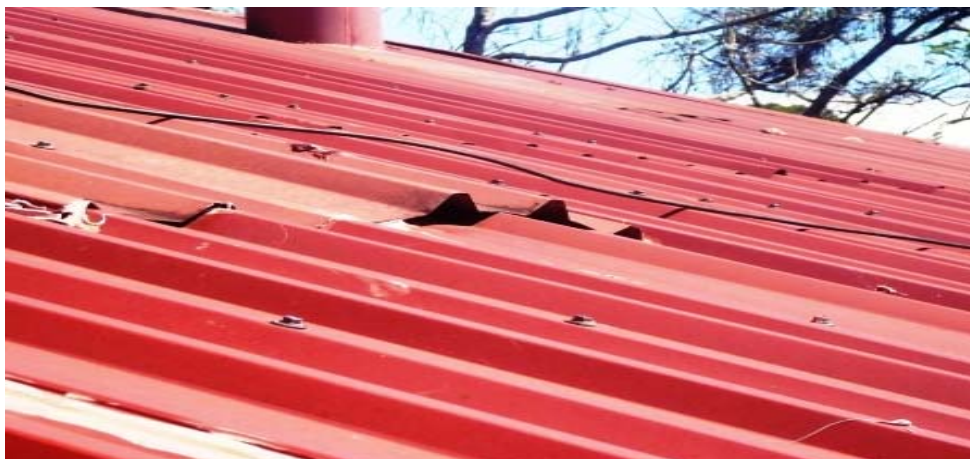
Additionally, when metal laminates move, the screws unfasten themselves and create larger holes where moisture can enter into the ceiling cavity and cause interior damage. In the photo below, you can see that this metal roof structure has corroded from water infiltration through gaps in metal laminates.

This is a serious problem that is difficult to repair and if allowed to continue will cause deterioration of the roof structures strength and replacement will be extremely expensive. This photo was taken in the attic of a home that was only three years old and constructed by a local commercial contractor.

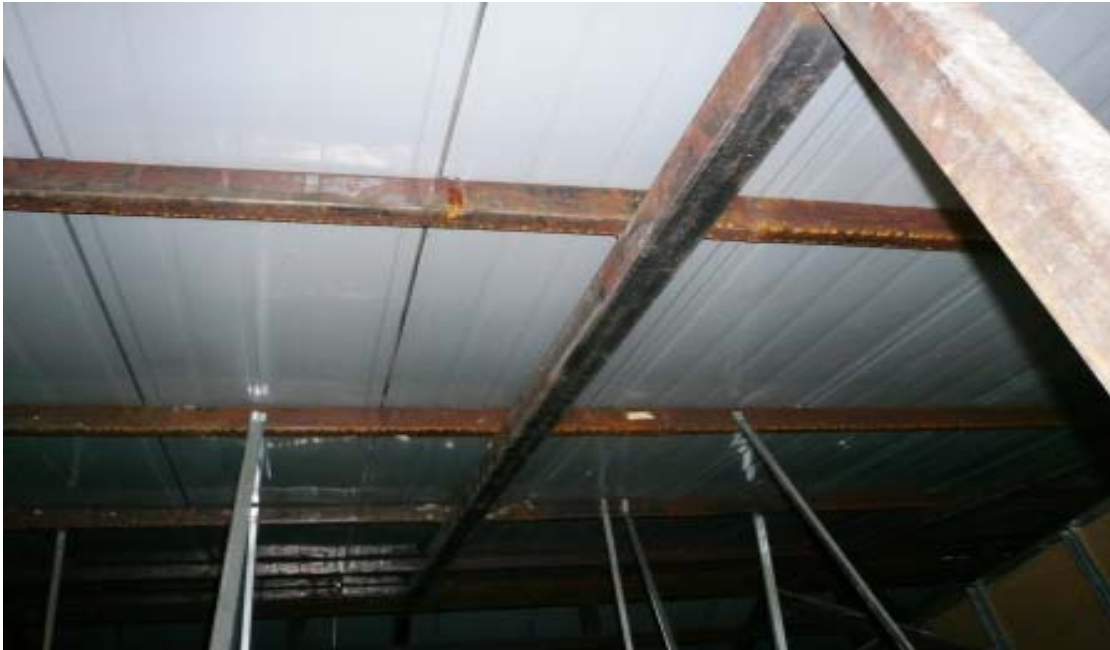
In the real world, most structural supports are installed every 24 inches on center in order to support adequate underlayment laminates and roof coverings.

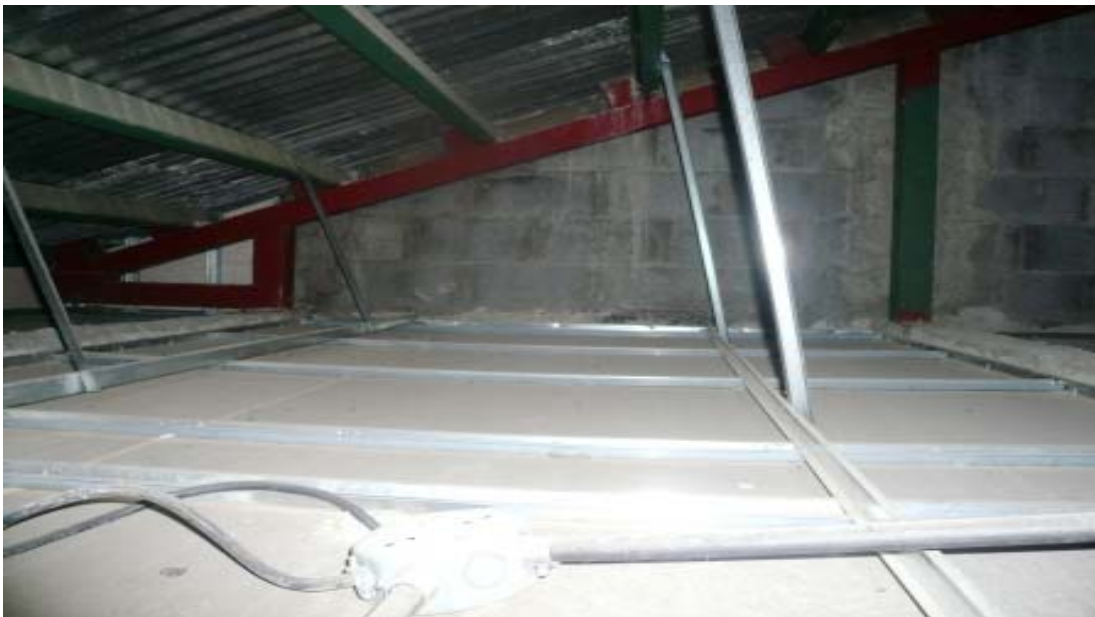
In Costa Rica there is little code enforcement and many times, in order to save money, contractors install roof supports every 36 or 48 inches, thereby using fewer structural supports and saving money.

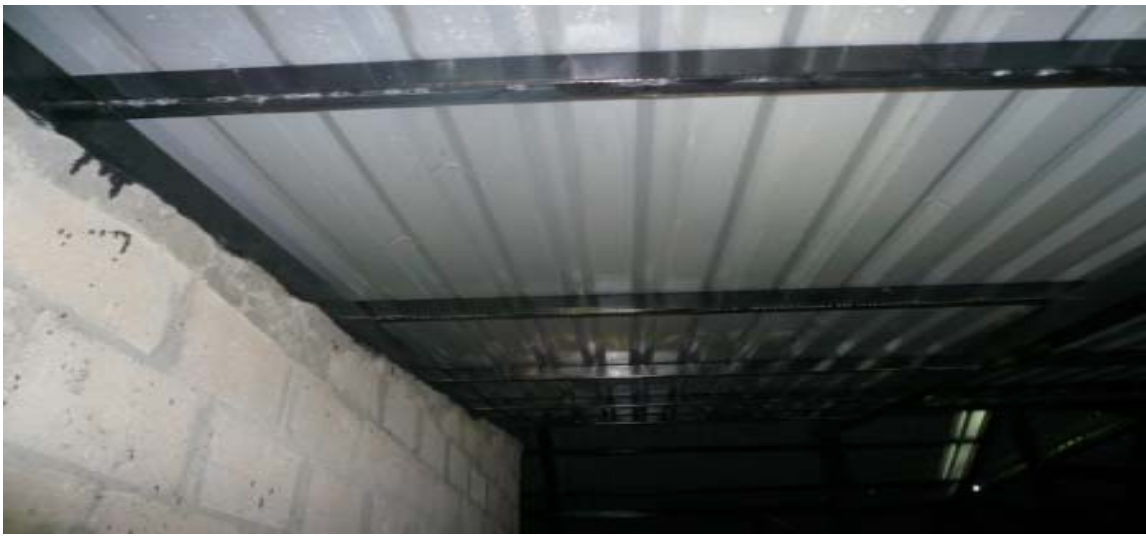
Unless the design of the roof structure included thicker gauge supports, there is little possibility of adding proper sheathing and waterproofing underlayment products after the fact, because lightweight structures cannot support the additional weight of construction products that need to be installed to create impermeable barriers and/or support roof tiles or other heavy roof coverings.

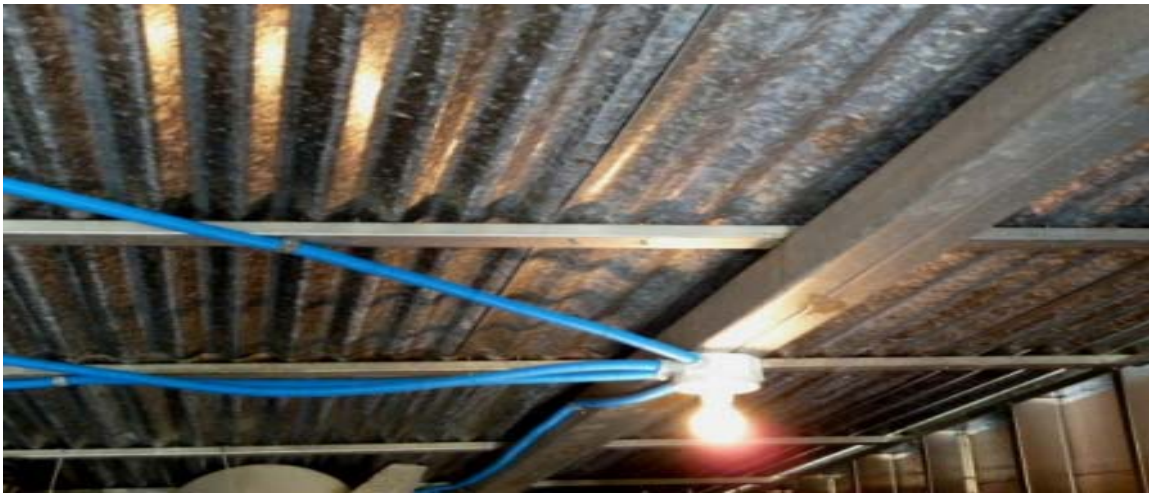
When roofing maintenance is necessary, workers will need to walk up on the roofs to make repairs. The metal laminates collapse in between structural supports that were spaced too far apart, from the weight of the workers. In these indentations, moisture accumulates and causes corrosion of the metal surfaces.
